# Manhole Inspection Summary

Manhole # S39Y1\_005MH

Insp Date: **11/15/07 1:12 PM**

**Location** Address: **3613 4th St**

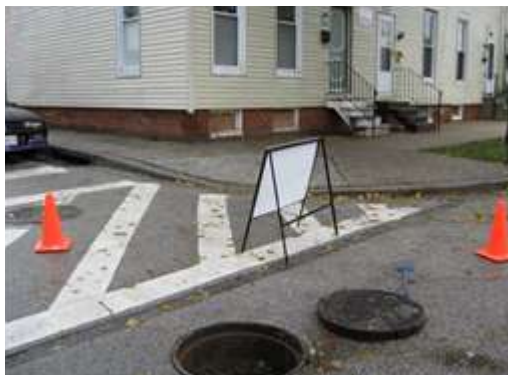
Location View

3615 4th Street

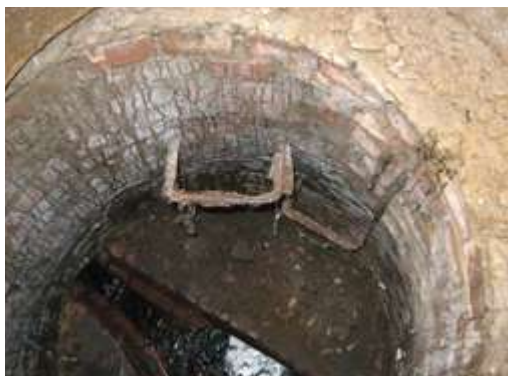
Count: **2** Missing: **0** ☒ **Corroded**

steps

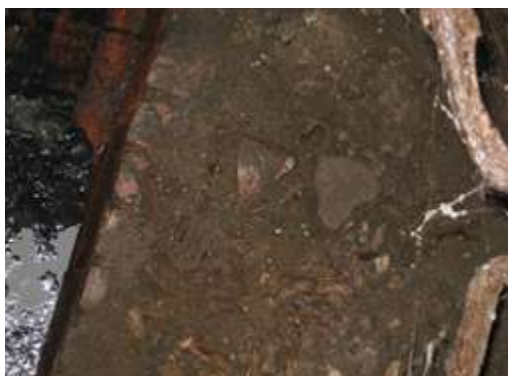
Defect 2

debris

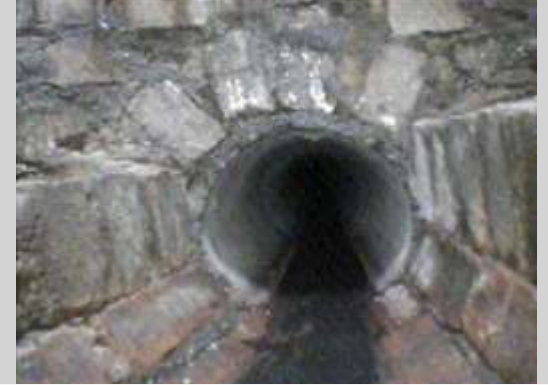
12 O'Clock Outflow

8 in. Circular Gravity Sewer  
Pipe Out @ 12 O'Clock

Pipe Height: **7.2** (in.) Rod and Bar (Angled)  
Pipe Material: **Clay** ☐ Pipe Lined  
Invert Depth: **6.39** (ft.) Flow Characteristics: **Slow**  
Deposits: ☒ None ☐ Mud ☐ Sludge ☐ Debris ☐ Grease  
Silt Depth: (in.) Deposits Extent:  
Infiltration: **None** Pipe Seal Cond: **Sound**

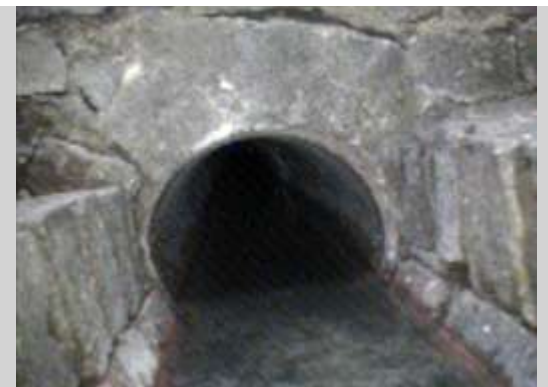
6 O'Clock Inflow

8 in. Circular Gravity Sewer  
Pipe In @ 6 O'Clock

Pipe Height: **8.4** (in.) Rod and Bar (Angled)  
Pipe Material: **Clay** ☐ Pipe Lined  
Invert Depth: **6.49** (ft.) Flow Characteristics: **Slow**  
Deposits: ☒ None ☐ Mud ☐ Sludge ☐ Debris ☐ Grease  
Silt Depth: (in.) Deposits Extent:  
Infiltration: **None** Pipe Seal Cond: **Sound**

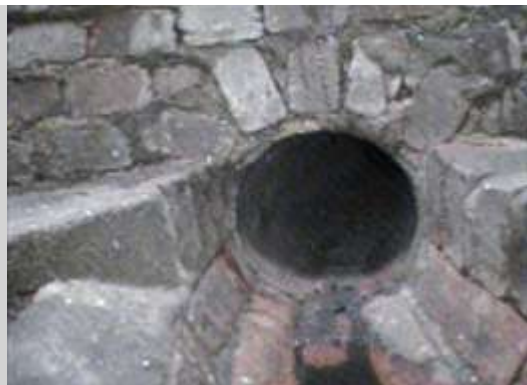
7 O'Clock Inflow

8 in. Circular Gravity Sewer  
Pipe In @ 7 O'Clock

Pipe Height: **7.2** (in.) Rod and Bar (Angled)

Invert Depth: **6.32** (ft.) Flow Characteristics: **None**

Infiltration: **None** Pipe Seal Cond: **Sound**

Connects To: **Dead End**
